University Lake Park

Site Inventory and Analysis Map

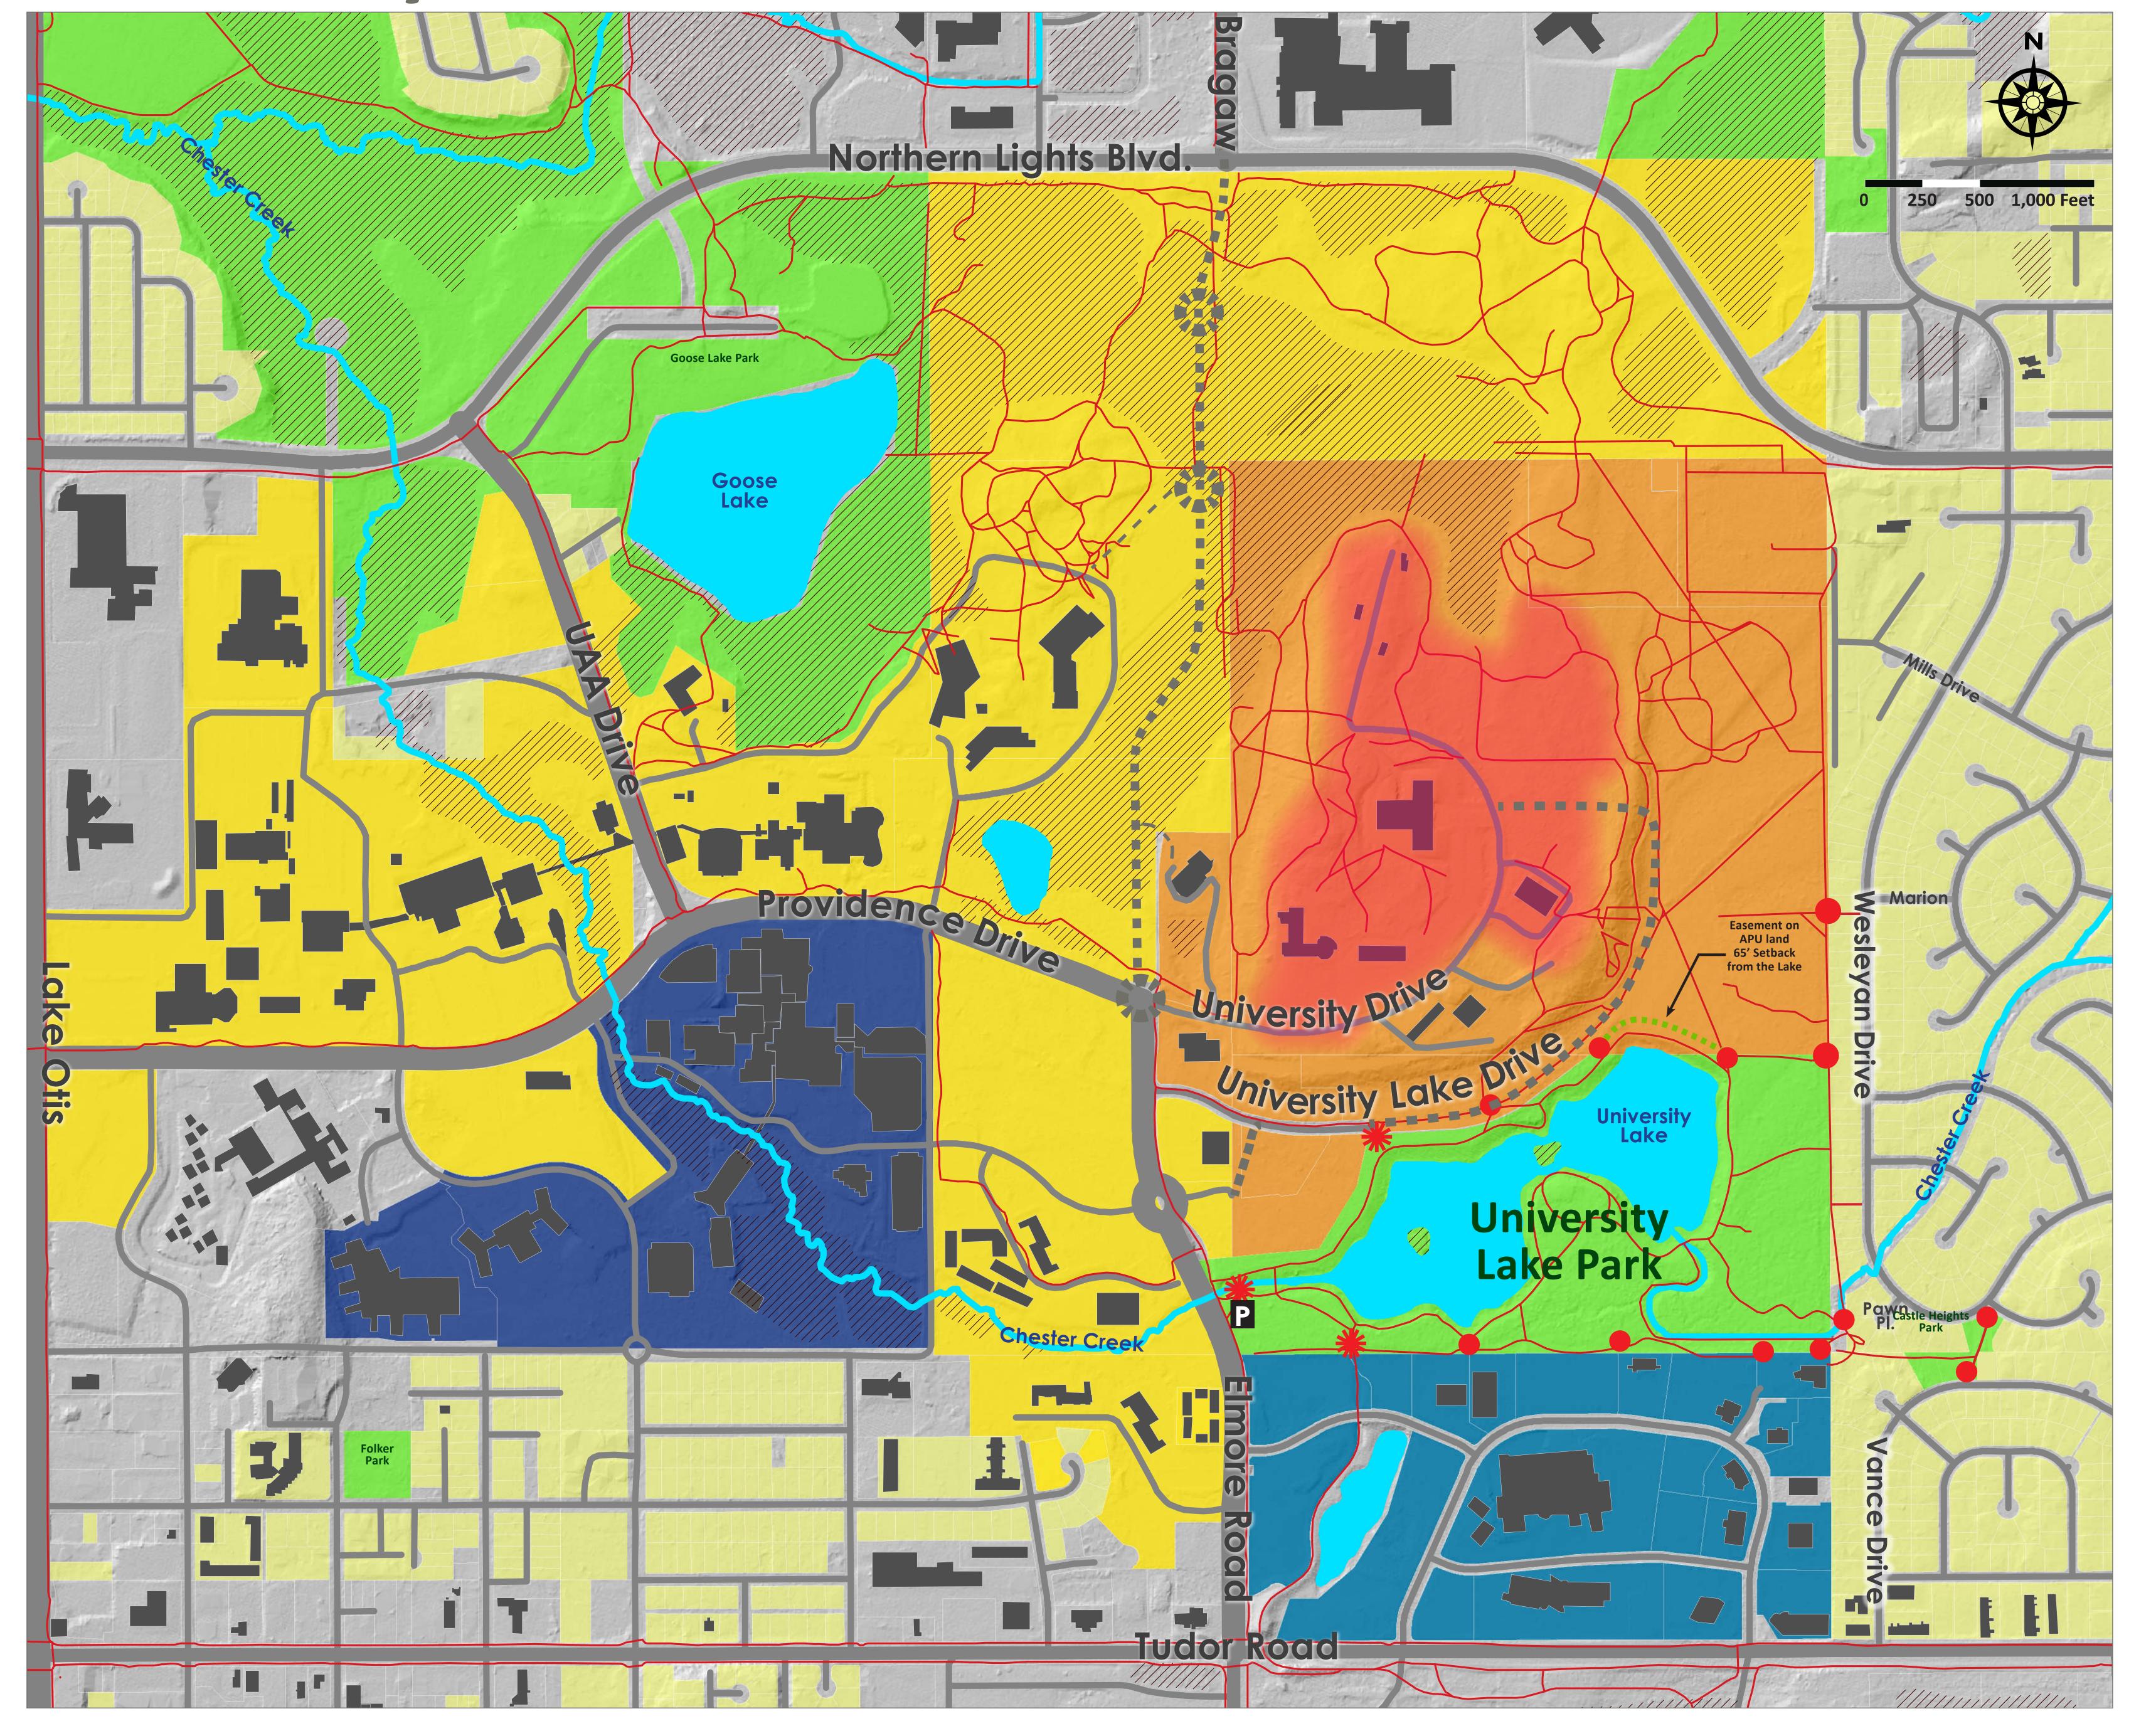
Context Map

Water Resources

Land Use/Ownership

Park Access & Circulation

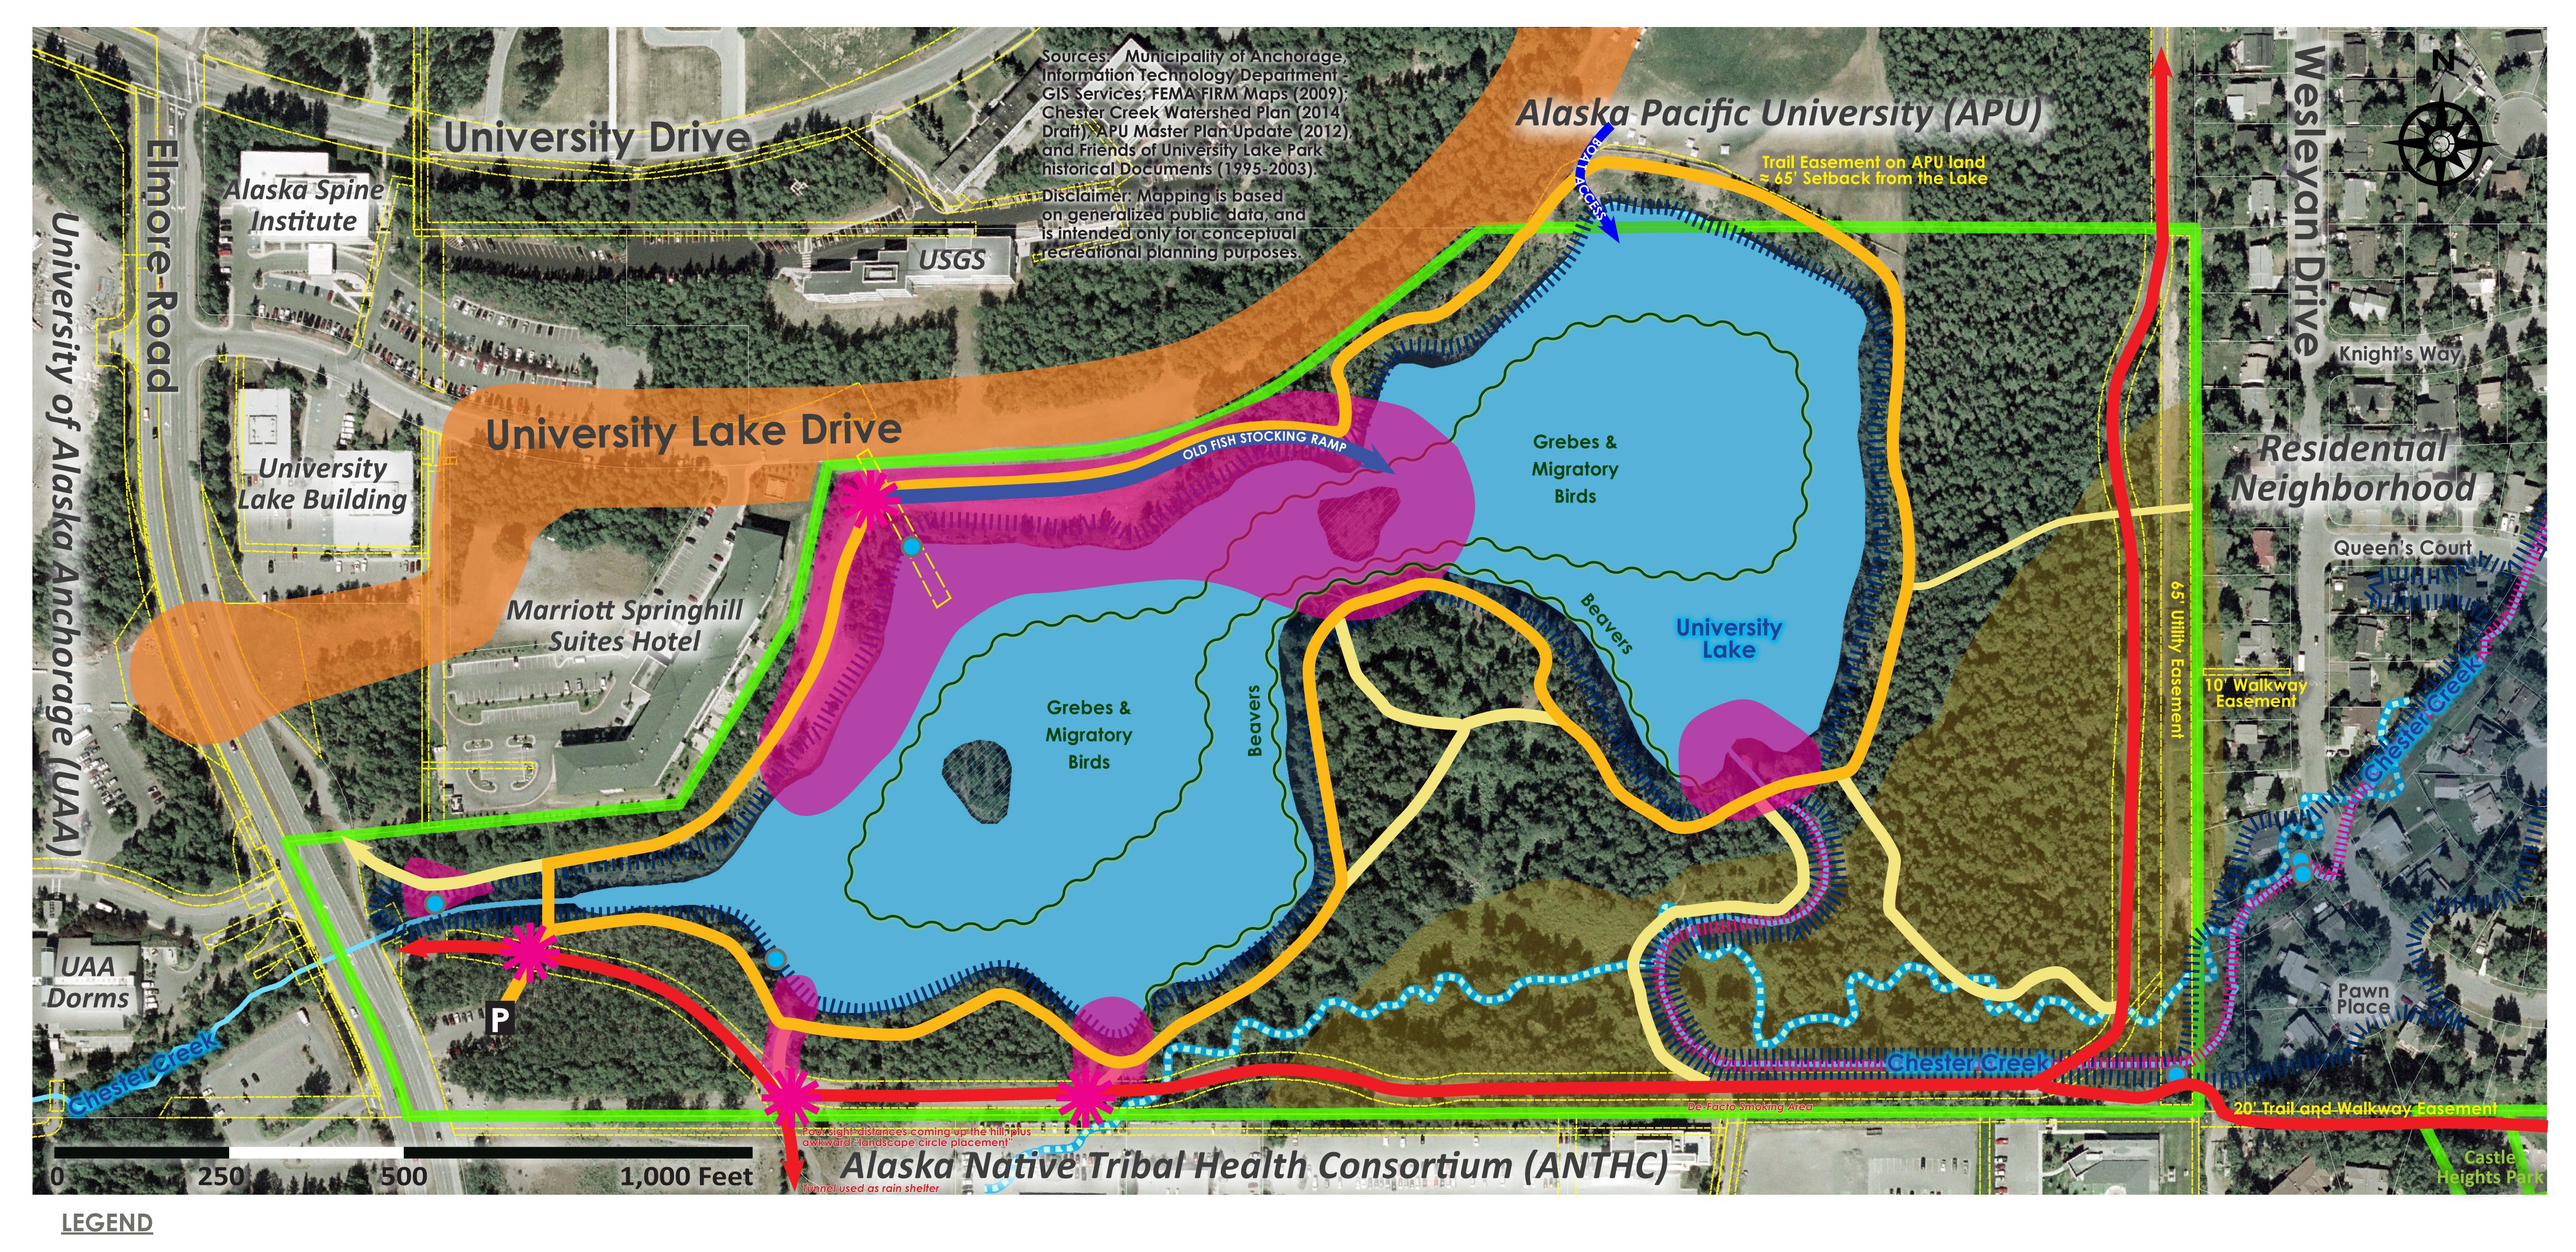
Site Context Municipal Parkland Parcel Boundaries (Private, Institutional) University Lake Drive (planned corridor)

Natural Characteristics

create University Lake.

University Lake
(Historical gravel pit, formerly "Behm Lake")

Pre-1980 Chester Creek Channel

Current Chester Creek Channel

Chester Creek was diverted to flow into an old gravel pit and

Unstable Channel, Poor Habitat
No riffle/pool complex suitable for fish, along with bank erosion, sloughing, and lake sediment deposits.
