## **Lewis & Clark**

### **Index of Professional Reports & Studies**

Attached to this application are reports from professionals in their field, they are tabbed from A to H, the below page numbers are as per the application.

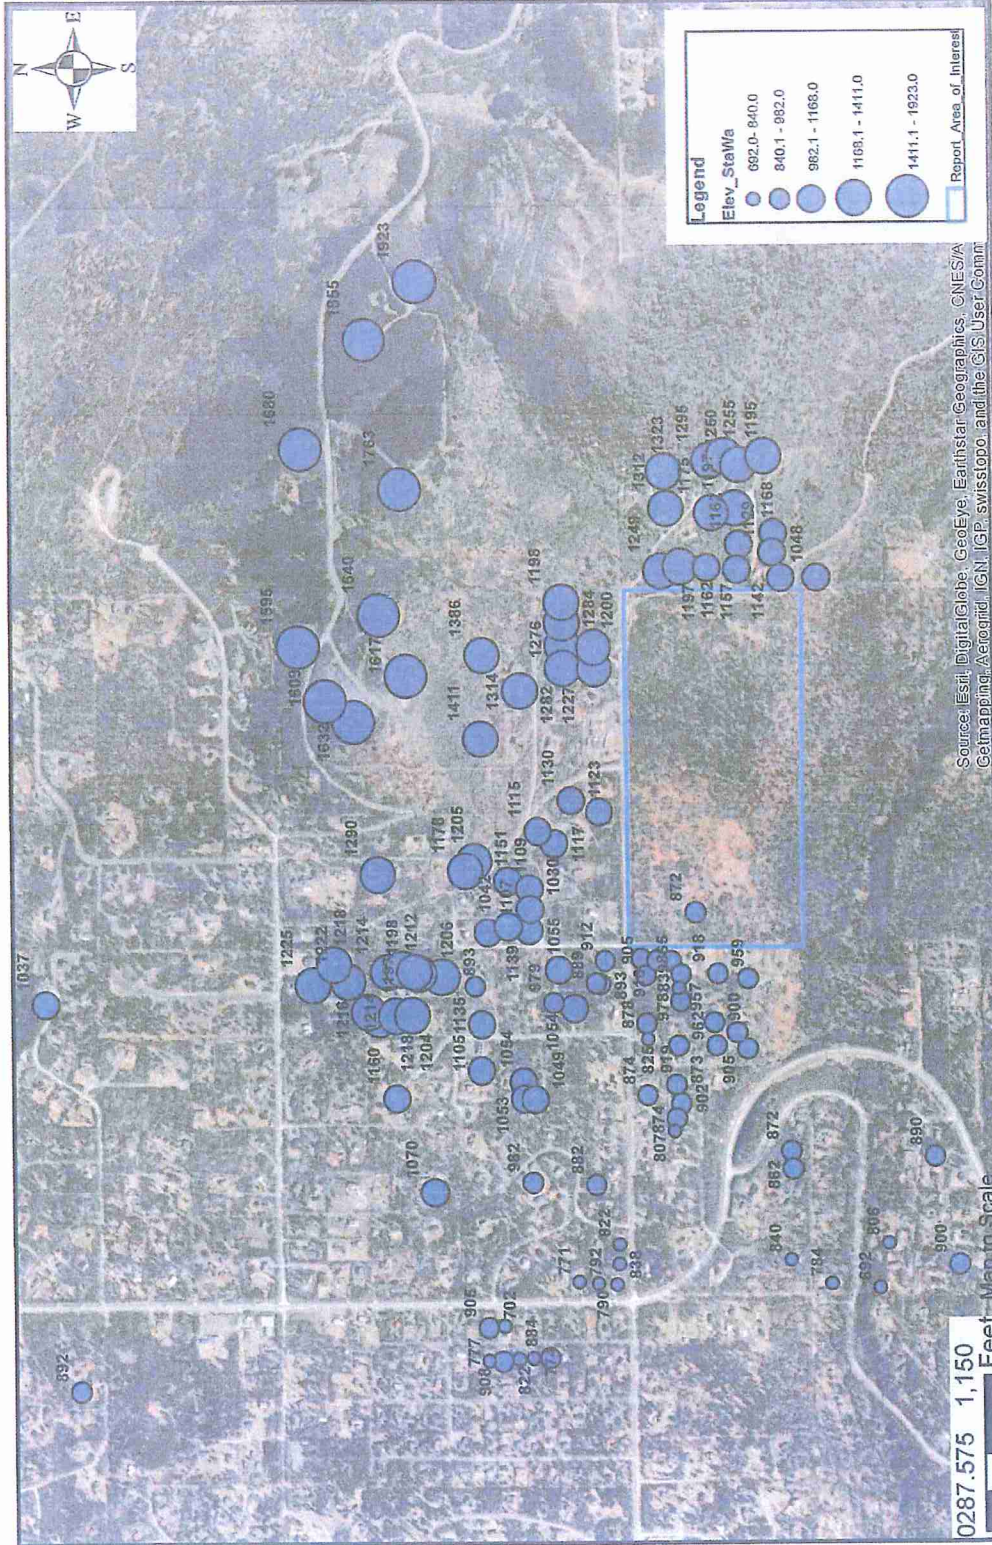
Figure 10

Static Water Elevations of Private Wells in  
Study Area Showing Evidence of Multiple Aquifers

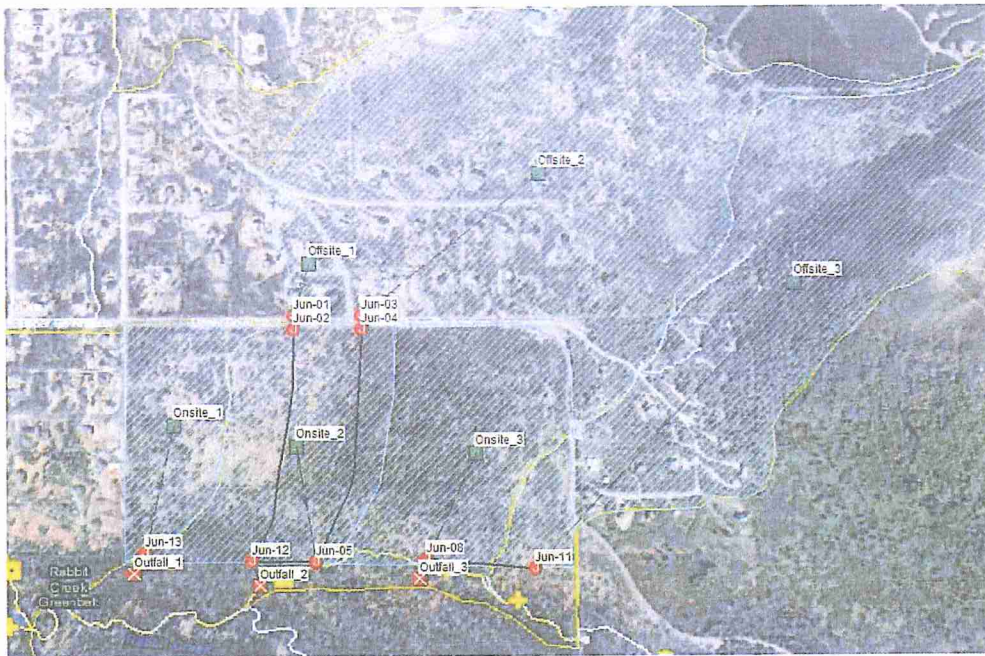
**b. Pre-development Watershed Map**

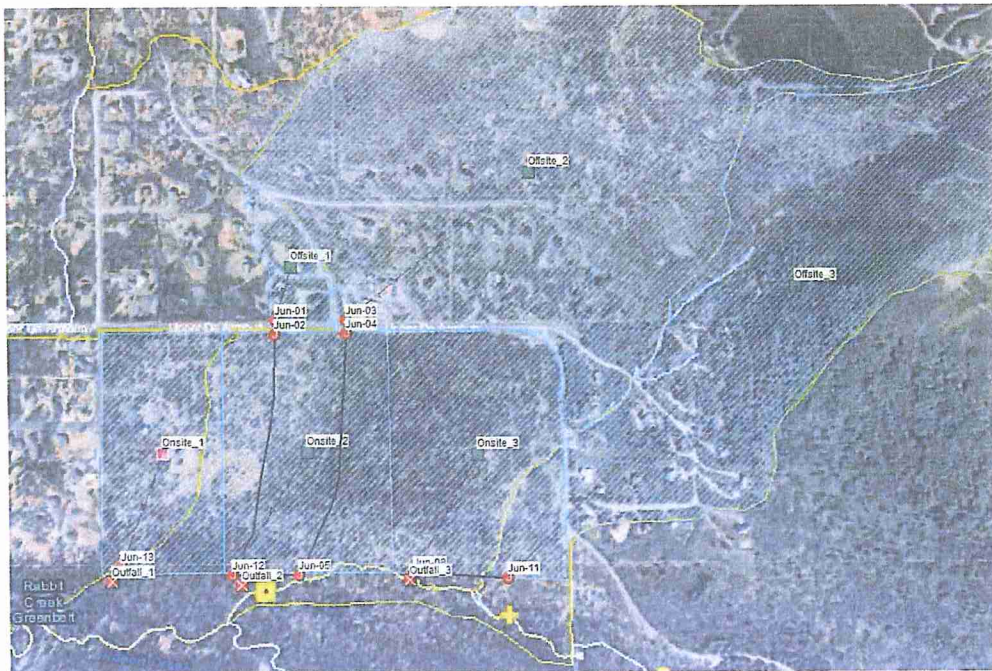
**c. Post-development Watershed Map**

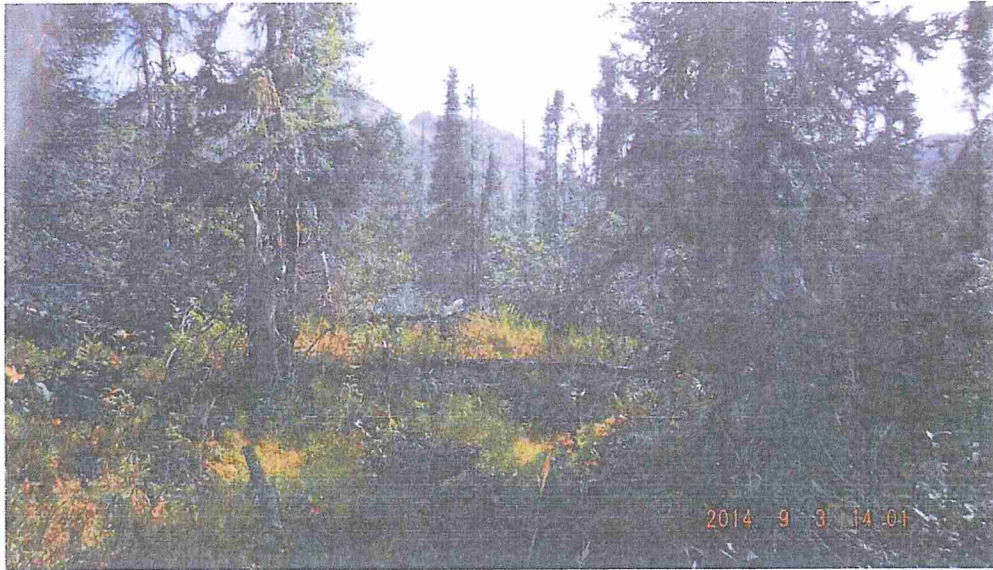
The observations made in Wetland #1 are documented in data sheets for DP-5, -6, and -7; surrounding uplands are documented in data sheets for DP-8, DP-13, and DP-4. This wetland can be characterized as *Palustrine, Needle-Leaved Forested / Emergent Persistent, Saturated* (PFO4/EM1B) by the Cowardin system.

Wetland #1 is separated from Rabbit Creek and the Upper Pond by several hundred feet of non-wetlands on relatively steep gradient. Subsurface flow through the loam soils in downslope uplands likely provides a hydrological connection with Rabbit Creek.

**Wetland #1.**
