MEMORANDUM

SUBJECT: S12456, Lewis and Clark Subdivision, Remand from the Board of Adjustment

**MUNICIPALITY OF ANCHORAGE
BOARD OF ADJUSTMENT APPEAL NUMBER 2018-1 FROM
ANCHORAGE PLATTING BOARD'S FEBRUARY 7, 2018 FINDINGS OF FACT AND DECISION IN
CASE NUMBER S12388**

**A conservation subdivision of Lewis and Clark
Subdivision, Lots 1 – 16 and Tract A, and 60-month
phasing plan with variances from AMC
21.07.060D.3.b.ii., *Internal Street Connectivity*, and
AMC 21.08.030F.6.a., *Cul-De-Sacs***

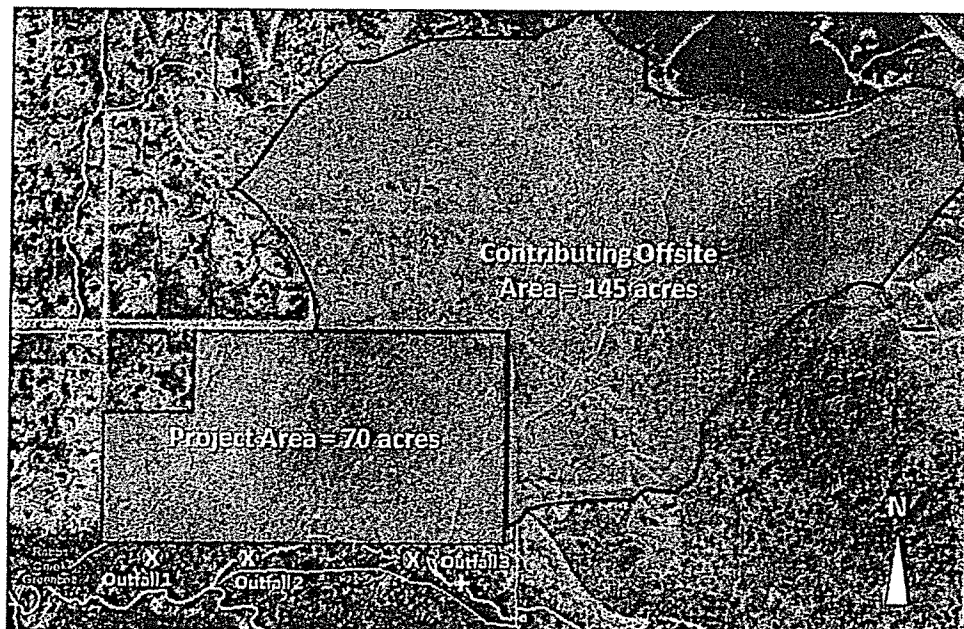
Lewis and Clark Contributing Drainage Map

Approximately 145 acres to the northwest of the site drains into the project area. This is a substantial area that contributes significant off-site runoff upstream of the project. The area is partially developed with large-lot single-family homes and access roads. A major portion of the offsite drainage area is undeveloped with woods and steep subalpine slopes. Flows are captured by roadside ditches and two, 24" culverts cross DeArmoun Road and discharge this offsite runoff into the project area. These flows are conveyed through the site by natural drainage ways which outfall to Rabbit Creek. A watershed map is shown below.

The contributing offsite area is more than double the size of the project area and generates significant flows that will be addressed in the final design of the subdivision.

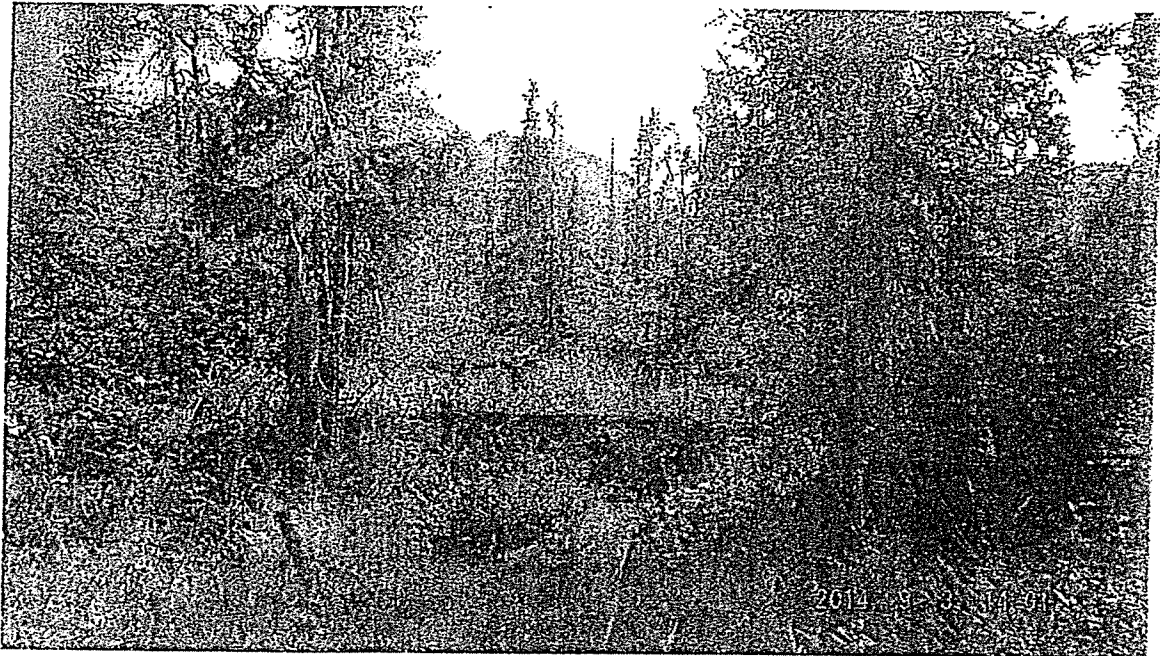
Wetland #1.

The observations made in Wetland #1 are documented in data sheets for DP-5, -6, and -7; surrounding uplands are documented in data sheets for DP-8, DP-13, and DP-4. This wetland can be characterized as *Palustrine, Needle-Leaved Forested / Emergent Persistent, Saturated* (PFO4/EM1B) by the Cowardin system.

Wetland #1 is separated from Rabbit Creek and the Upper Pond by several hundred feet of non-wetlands on relatively steep gradient. Subsurface flow through the loam soils in downslope uplands likely provides a hydrological connection with Rabbit Creek.

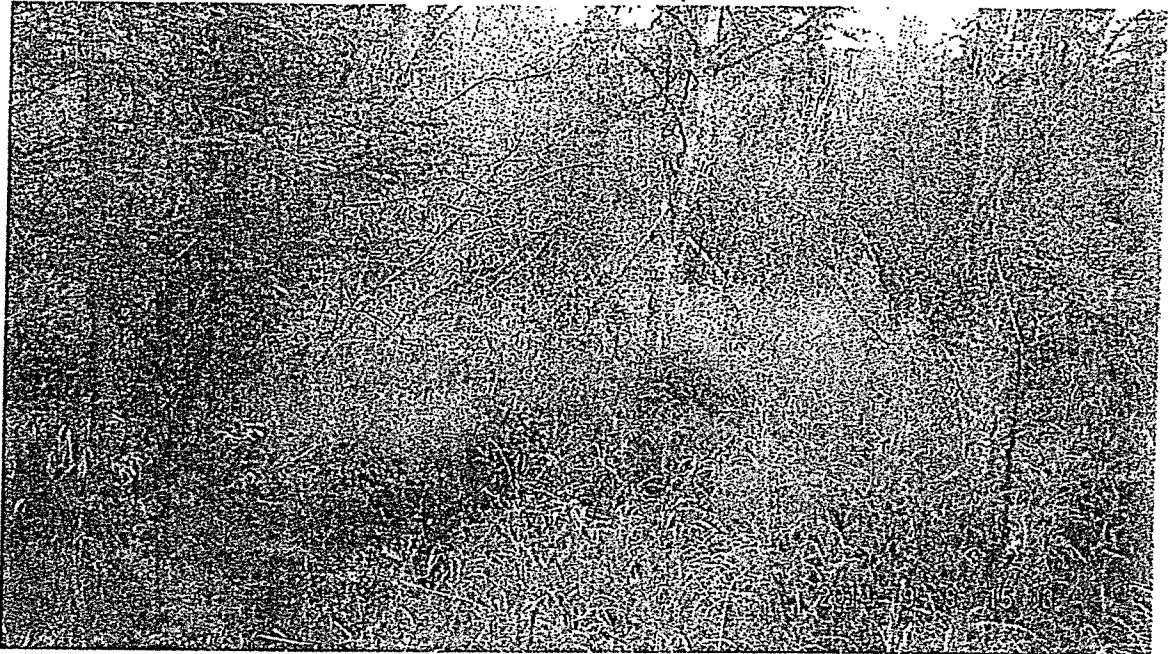
Wetland #2.

Wetland #2 is located in the south part of the property and includes 5.762 acres of seasonally flooded black spruce forest and emergent marsh on a sloping terrace that drains south to Rabbit Creek. Several springs emerge from the base of the slope separating the uplands to the north and flow as small streams to the south. Much of the area is densely wooded with black spruce, birch, and alder; some of the large spruce trees succumbed to beetle kill and litter the area, making foot access difficult. The emergent vegetation is characterized by bluejoint reed grass *Calamagrostis canadensis* (FAC) and sedges *Carex* spp. (most species are FAC, FACW, or OBL).

This wetland can be characterized as *Palustrine, Needle-Leaved Forested / Emergent Persistent, Seasonally Flooded* (PFO4/EM1C) by the Cowardin system.

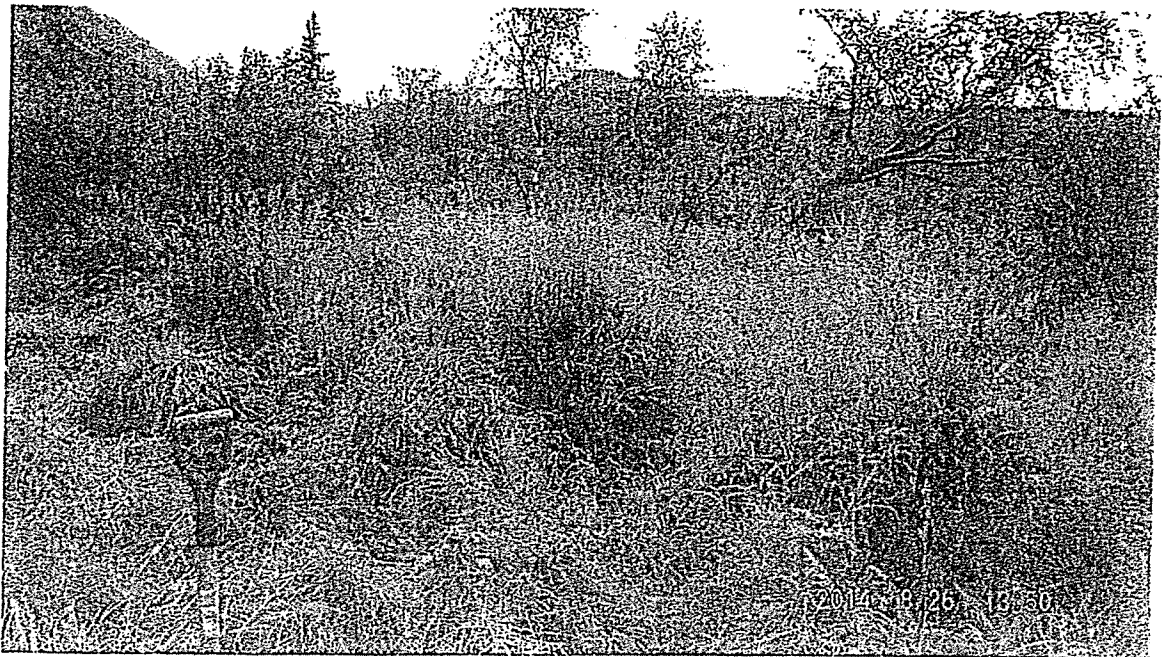
Upland Bluejoint Reed Grass Vegetation at DP-9.

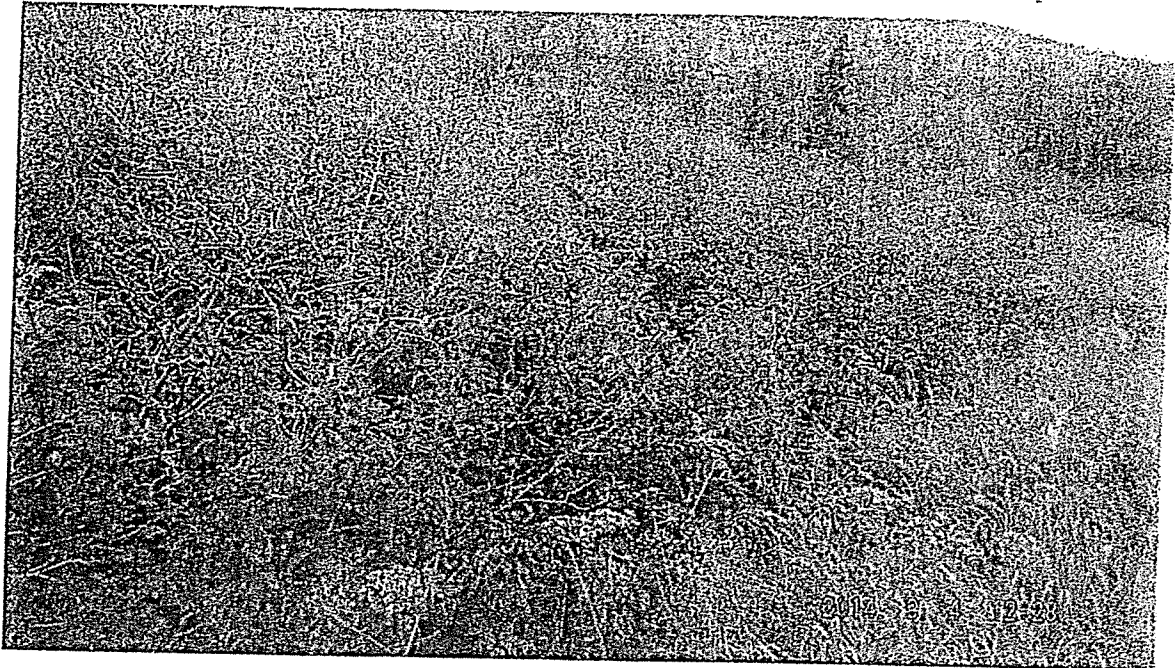
Rabbit Creek Tributary Channel (obscured in alder brush).

Streams are present on the property including the MOA-mapped Rabbit Creek tributary channel, which enters the parcel on the east side via a culvert beneath Canyon Rd. and extends south following the steep grade in the southeast corner of the parcel. A tributary of the creek was located near the south property line, identified as Stream #1 and was flowing with a small amount of discharge, estimated at less than 1 gallon per minute. Above the confluence with this tributary, the channel Rabbit Creek on the property was dry during the inspection.

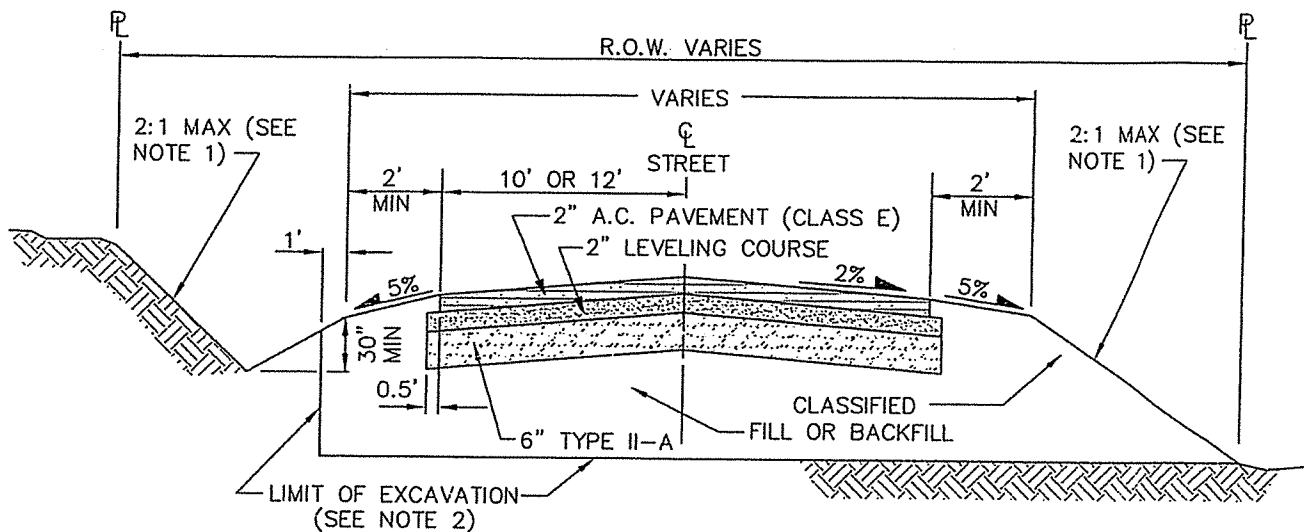
TYPICAL SECTION - 20'/24' STRIP PAVING

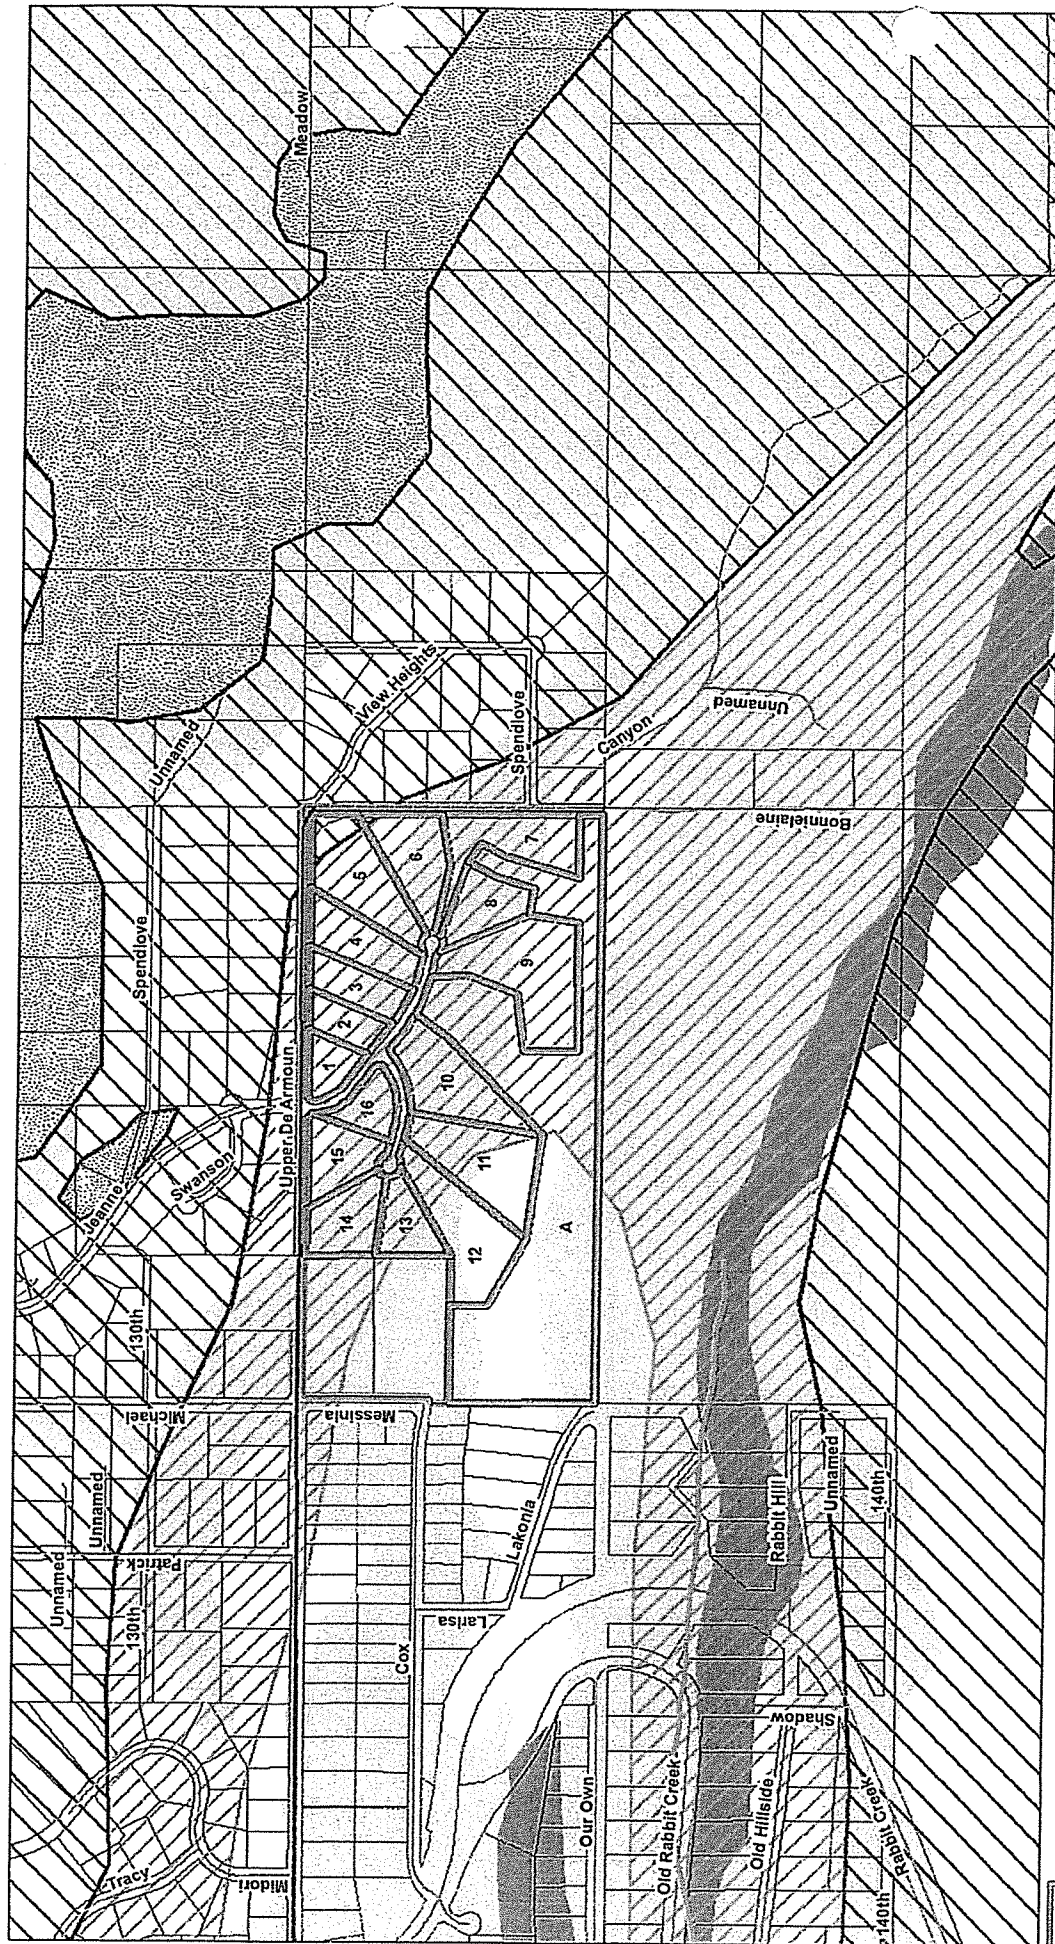
Proposed Redevelopment Parcels with Soils Classification for On-site Wastewater Systems
DRAFT
