**Brownfields Cleanup Grant
Cooperative Agreement #BF- 96085101
Municipality of Anchorage, Peacock Cleaners**

Closeout Report

DECEMBER 2012

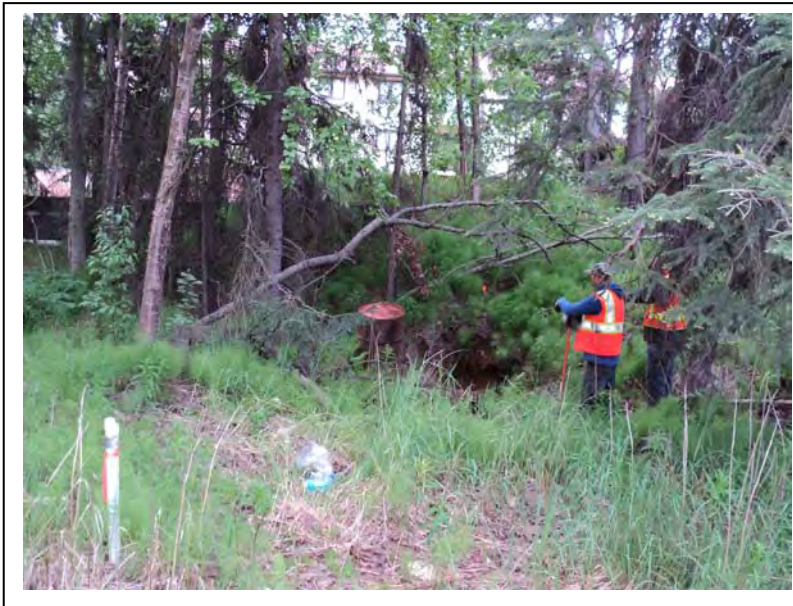
Photo 1: Facing southeast, Drum 1 can be seen in the partially buried drum area. Behind it is the earthen berm, and Monitoring Well B5MW can be seen in the left foreground. (6/9/2011)

MOA contracted with Shannon & Wilson and their subcontractors to remove the buried Stoddard solvent tank and partially-buried drums to mitigate surface waste materials and eliminate potential ongoing sources of subsurface contamination.

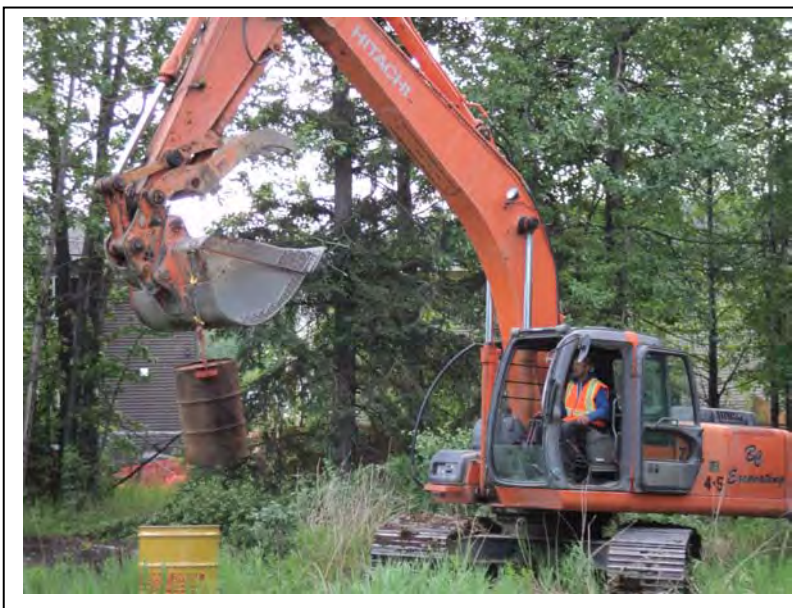
Photo 2: The drum with liquid contents (Drum 1) was placed in an overpack drum. (6/9/2011)

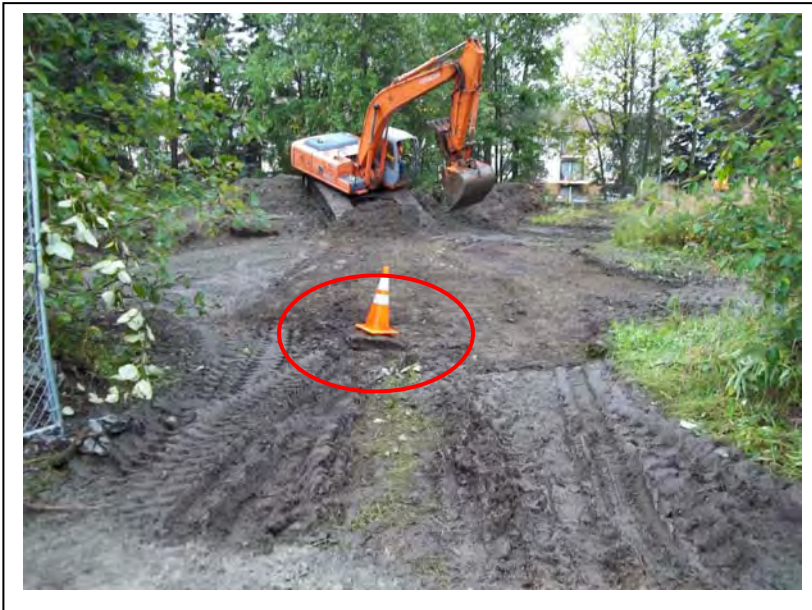
Photo 3: Facing south, the location of the potentially-damaged Monitoring Well MW16 is circled. (9/1/2011)

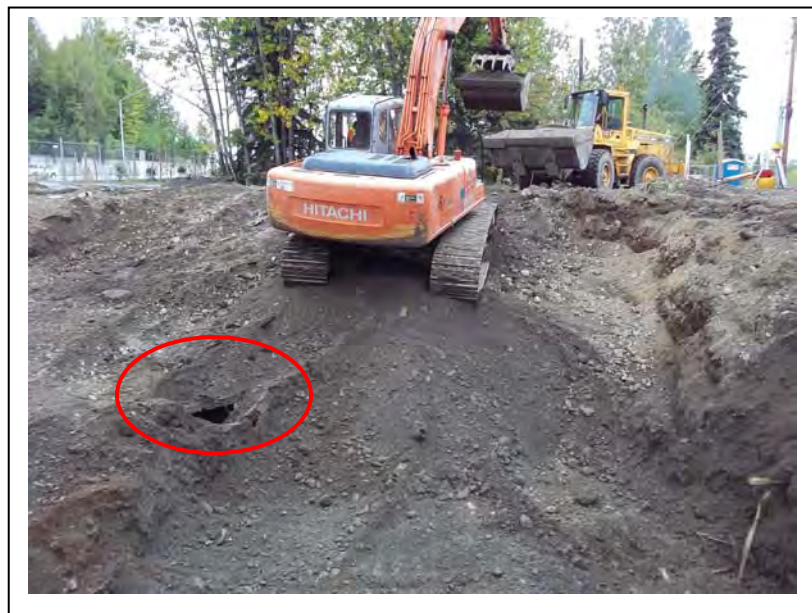
Photo 4: Facing north, the lid of the dry well is circled. (9/6/2011)

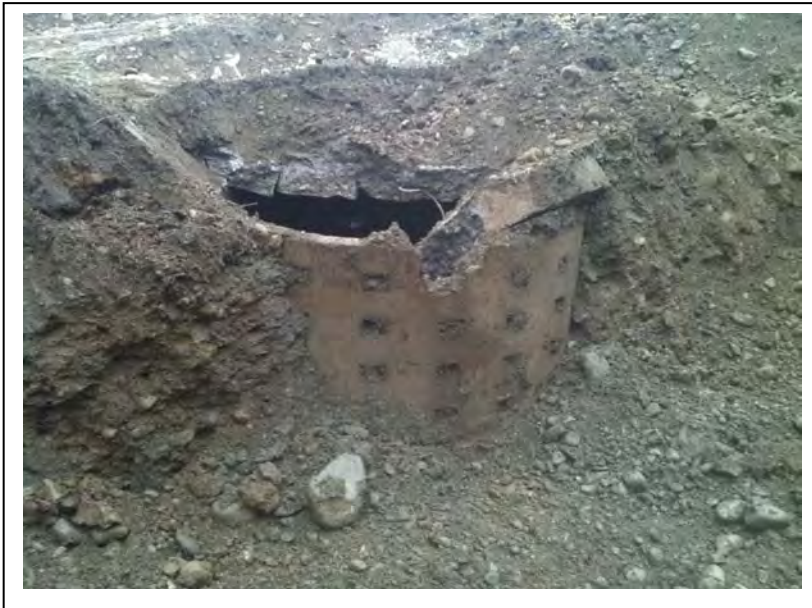
Photo 5: The dry well consisted of a 4-foot diameter perforated concrete pipe. (9/6/2011)

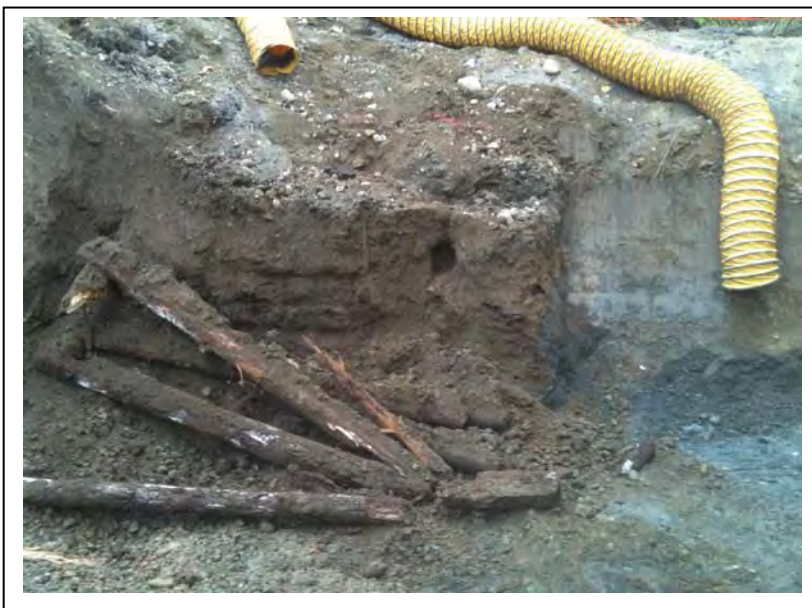
Photo 6: Facing east, the exposed portions of the log crib are shown. (9/6/2011)

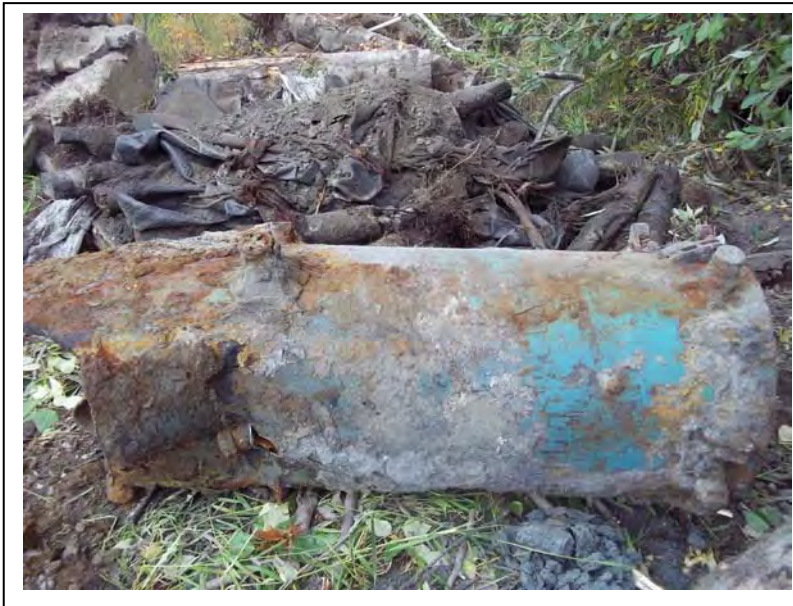
Photo 7: The process tank was found in the eastern portion of the excavation. (9/7/2011)

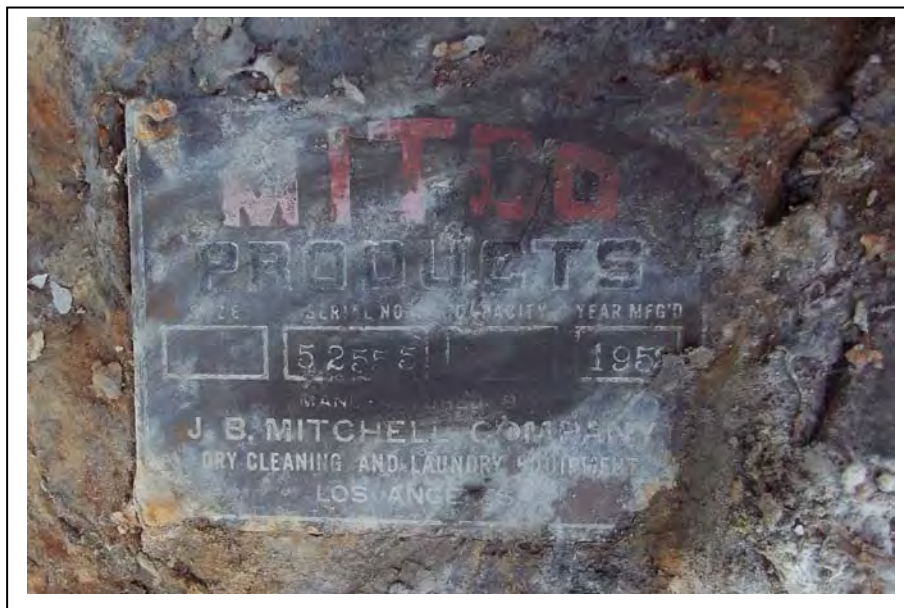
Photo 8: The process tank placard indicates that the tank is “dry cleaning and laundry equipment.” (9/13/2011)

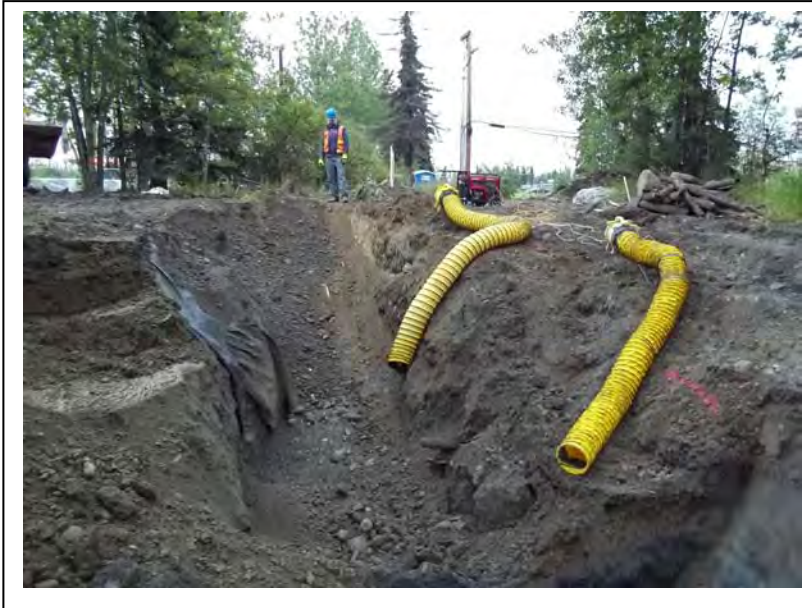
Photo 9: Facing north, fans provided ventilation during the excavation to reduce organic vapor concentrations. (9/2/2011)

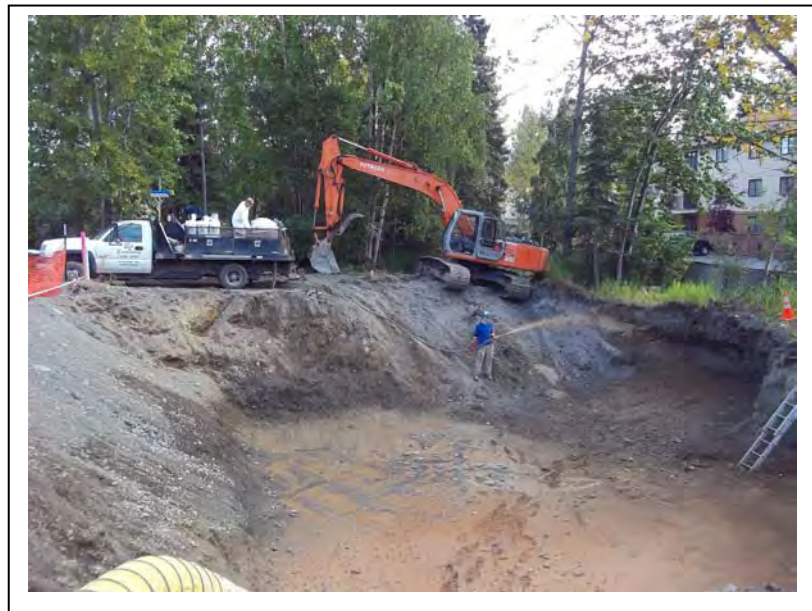
Photo 10: Facing east, a pump on a truck-mounted water tank was used to apply the oxidant mixture to the base of the first lift of the treatment cell. (9/8/2011)

The in-situ remediation system was installed in September 2011. An estimated 1,190 cubic yards of soil were excavated and consolidated within on the site. Field screening results were used to select the most heavily-impacted 600 cubic yards of soil for in-situ treatment. The remaining excavated soil was used to backfill the excavation in areas outside the treatment cell's designed radius of influence. Two arrays of horizontal passive soil vapor extraction pipes were placed in the in-situ treatment cell; five pipes were placed at 5.5 feet below ground surface and five pipes were placed at 10 feet below ground surface. In addition, Regenox-brand oxidant was applied to the backfilled soil in 1- to 1.5-foot lifts.

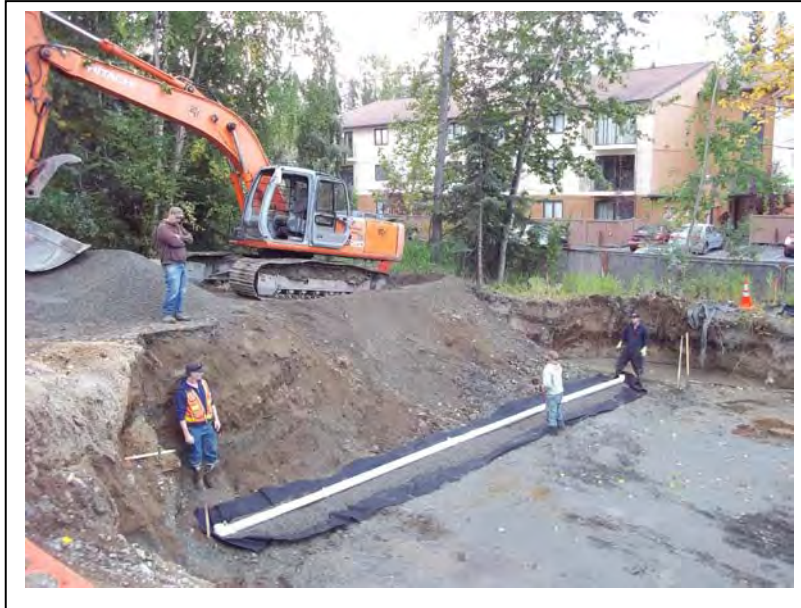
Photo 11: Facing southeast, the deep horizontal vapor extraction piping was bedded in pea gravel and wrapped in geotextile fabric at 10 feet bgs to allow air flow, protect the pipe, and prevent silting.

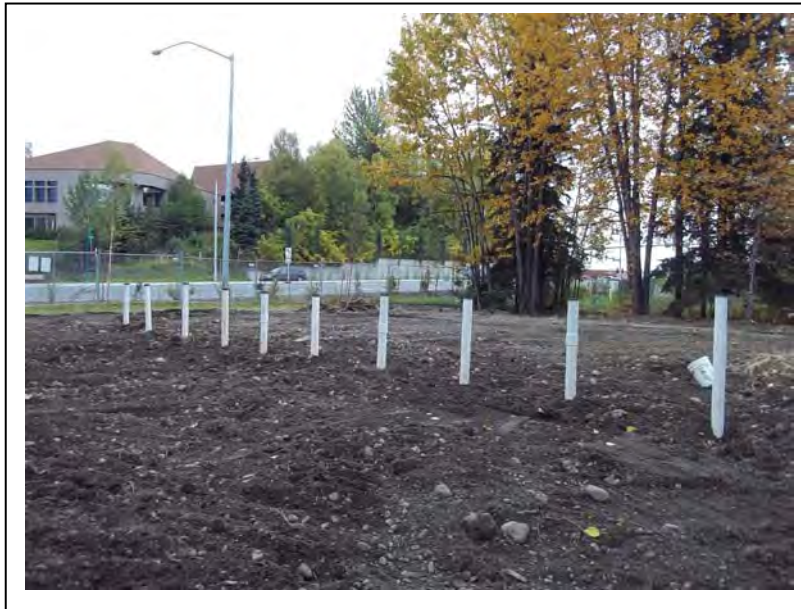
Photo 12: Facing northwest, the VES array was completed with vertical riser pipes. Rubber slips caps were installed on the north array. (9/16/2011)

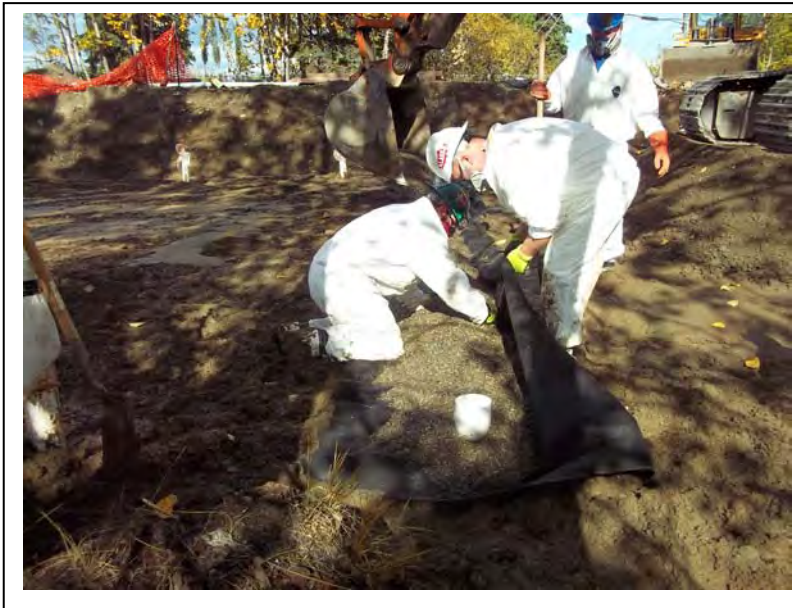
Photo 13: Facing north, the vapor horizontal vapor extraction system components include a 4-inch slotted PVC pipe which was bedded in pea gravel and enclosed in a geotextile. (9/13/2011)

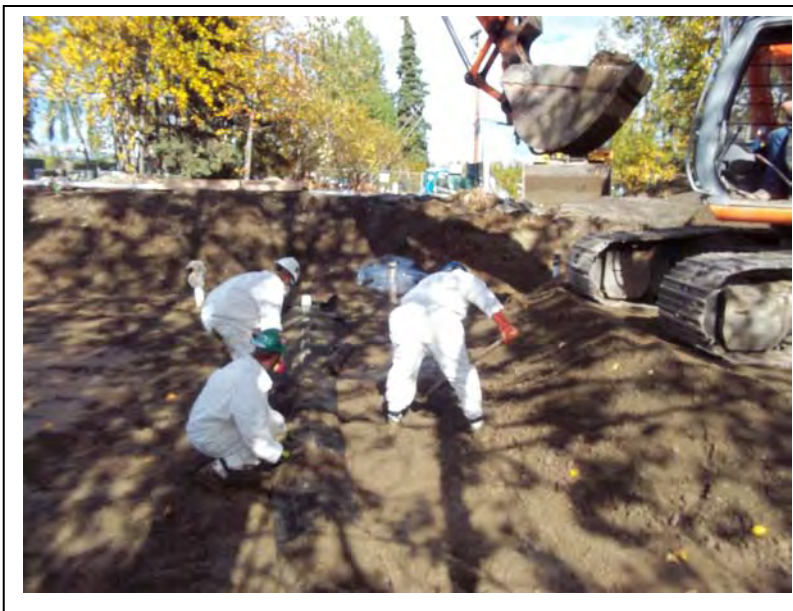
Photo 14: Facing north, BCX completed the VES installation by shoveling pea gravel on the horizontal pipe, closing geotextile, and placing soil over the assembly to prevent the geotextile from opening. (9/13/2011)

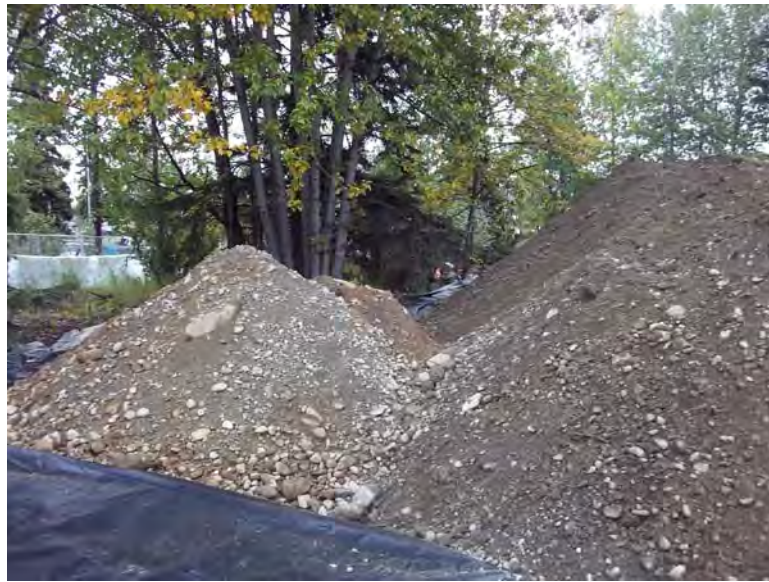
Photo 15: Facing east, the north consolidation area is shown, with the soil pile with >1,000 ppm screening results on the left, and soil with <100 ppm screening results on the right. (9/6/2011)

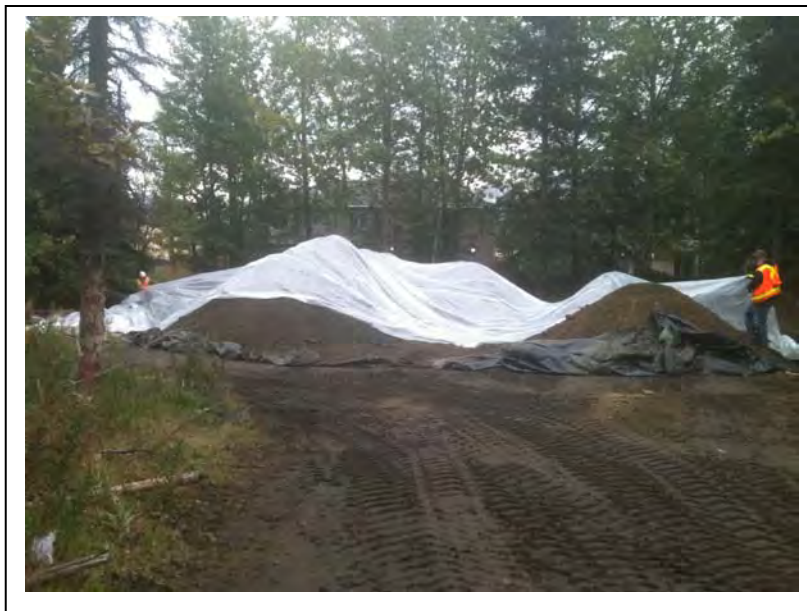
Photo 16: Facing east, BCX removes the 6-mil liner from northeast consolidation area. Soil was segregated in piles, with soil with the lowest screening results (<1 ppm and <5 ppm) in piles on the right. (9/2/2011)

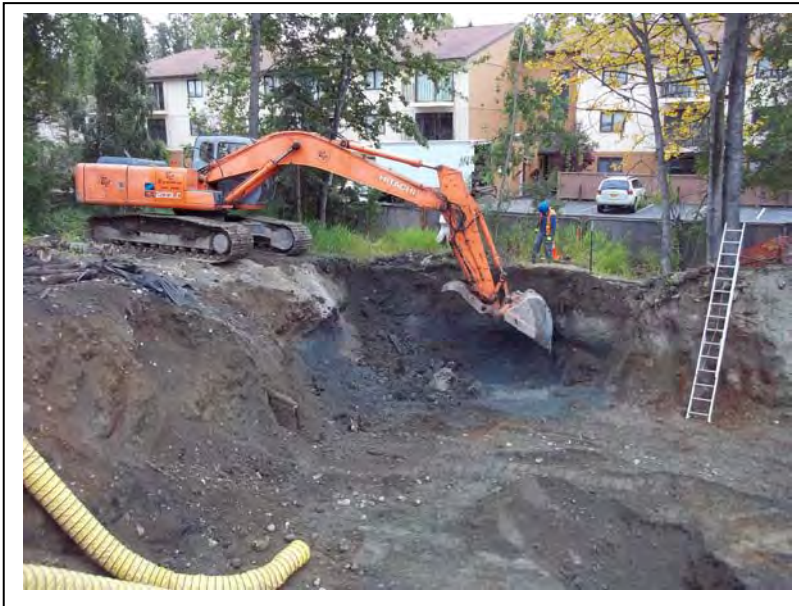
Photo 17: Facing southeast, BCX is conducting the targeted additional excavation. Gray ash-like material indicative of impacted soil is below the excavator bucket. (9/7/2011)

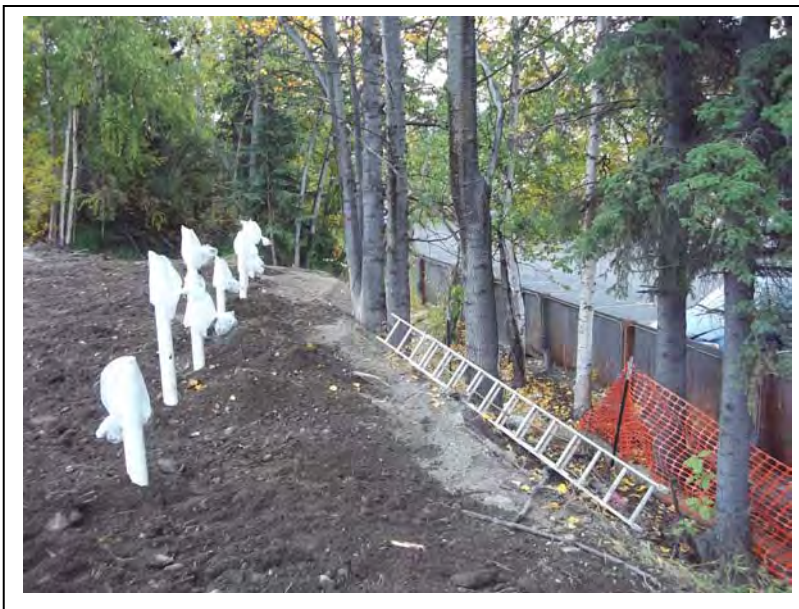
Photo 18: Facing east, the south VES risers can be seen. To the right (south) of the risers, the property slopes down, and trees and a fence are present. (9/15/2011)

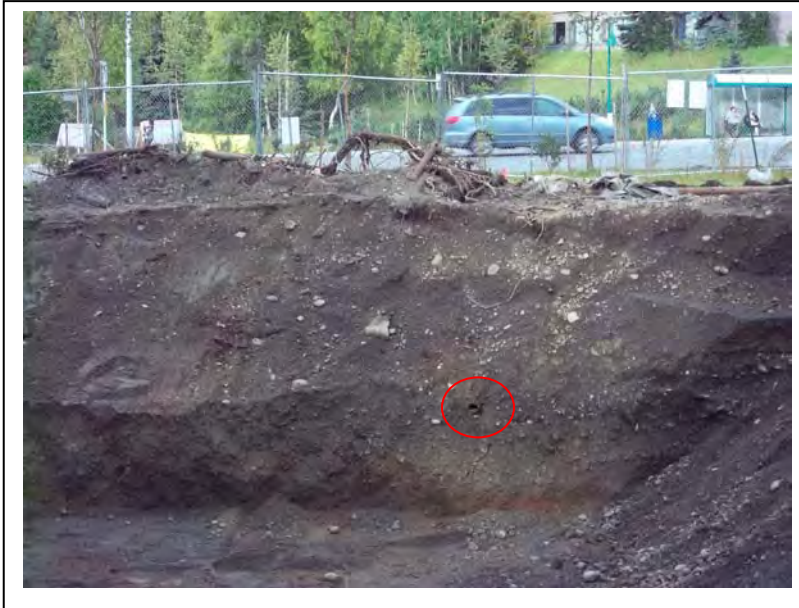
Photo 19: Facing west, the location of the bituminous fiber pipe on the west wall of the excavation is circled. (9/7/2011)

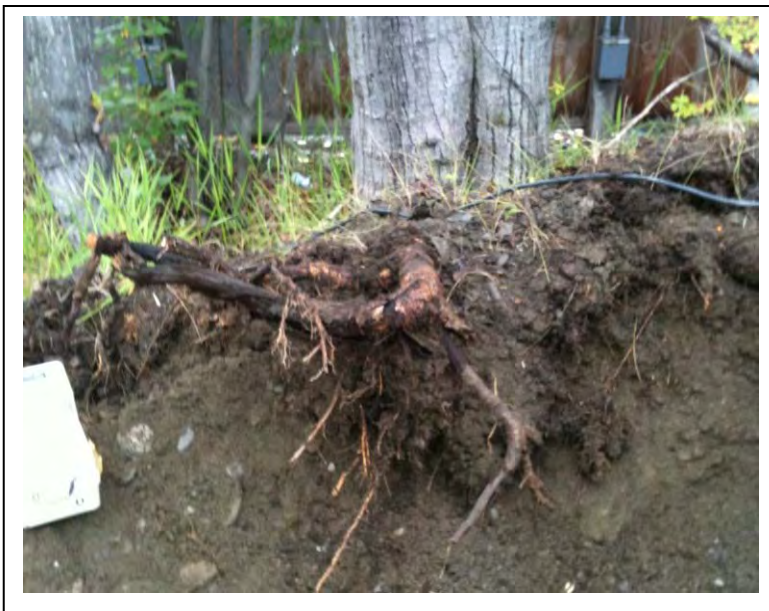
Photo 20: Facing south, the root wad on the south edge of the excavation prior to removal. (9/2/2011)
