# Earthquake Resiliency and Building Code Enforcement

## Is there a connection?

David Askov and Amanda Siok, FEMA  
 Ross Noffisinger and Tina Miller,  
 Municipality of Anchorage  
 John Thornley, Golder Associates, Inc.

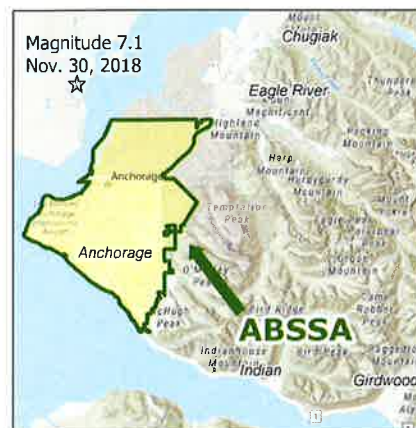
### The Anchorage Building Safety Service Area (ABSSA)

**Building Code Enforcement:** The "Anchorage Building Safety Service Area" (ABSSA) primarily consists of the Anchorage Bowl. Building permits within the ABSSA require a plan review and a building inspection with a municipal inspector.

**Outside the ABSSA:** The Municipality of Anchorage does not require plan reviews and municipal inspections for construction outside of the ABSSA, including the communities of Eagle River, Chugiak, Indian, and Girdwood.
